## 11 | BREAKAGE AND DETACHMENT

It can be noted in the following pages how most problems have transpired when installing panel models, as they are often considered similar to tiles and therefore easy to install. The installation of Geopietra® wall coverings is completely different however, as a double application is required in addition to a careful assessment of the installation base. Geocoll® adhesive has special characteristics for dealing with the various stresses created between bases and wall coverings (see section 4).

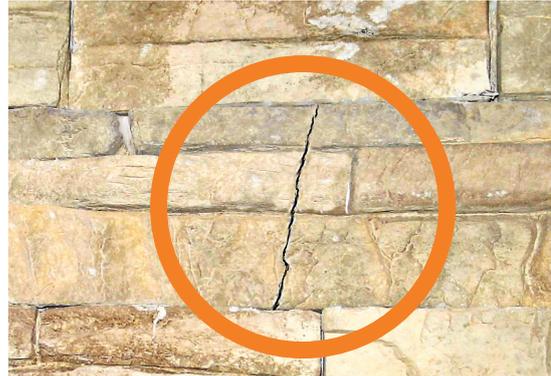
### 1. CENTRAL BREAKAGE IN PANEL MODELS.

The crack shown in the photograph, found on the longer sections of panel models, can be caused by two installation errors:

- 1) applying adhesive between two spacers at the ends of the piece, where the stresses due to different thermal expansions cause breakage.
- 2) installing using a rubber mallet to make the section adhere to the base, resulting in the section cracking.

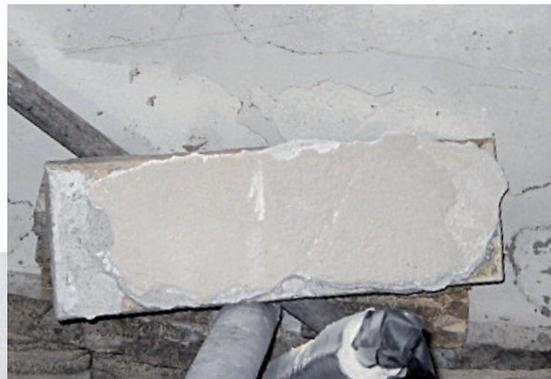
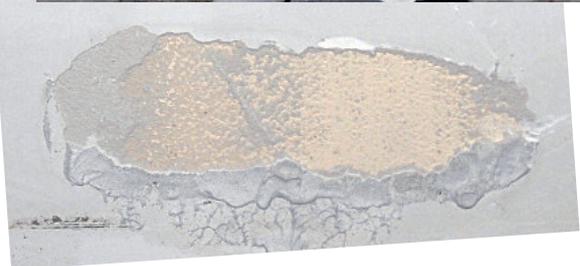
### 2. INCORRECT INSTALLATION ON A SKIM COAT.

A skim coat was applied to a plastered surface then the stone was glued without using a double application of adhesive. This resulted in the covering coming off completely (note the marks left by the adhesive in the lower part of the photo). The pull-off test carried out afterwards also shows the unstable condition of this base and the effectiveness of adhesion provided by the Geocoll® adhesive.

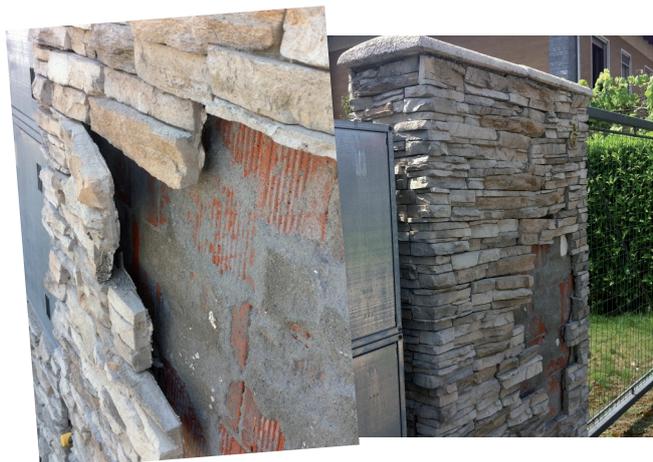
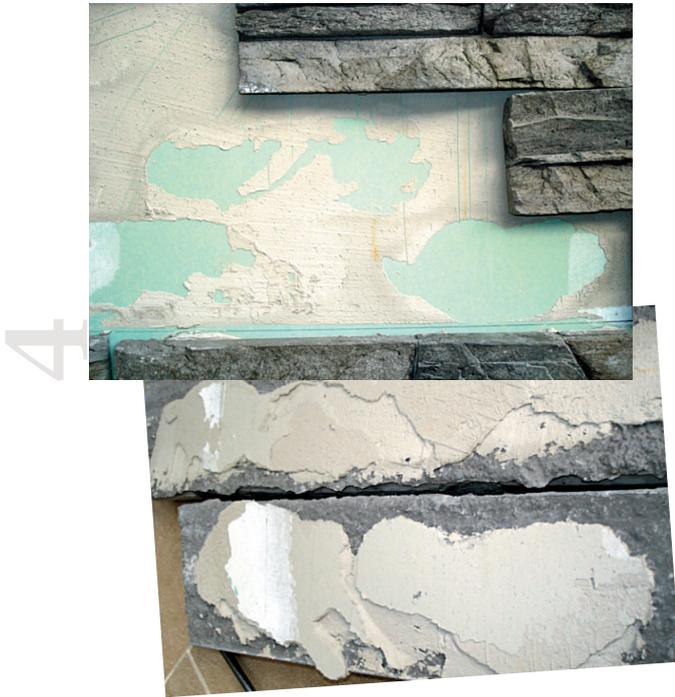
### 3. INCORRECT INSTALLATION ON EXTERNAL BRICK.

Structures subjected to bad weather are not usually implemented with absorbent materials. The case illustrated shows the results of a wall covering placed on an external brick base.

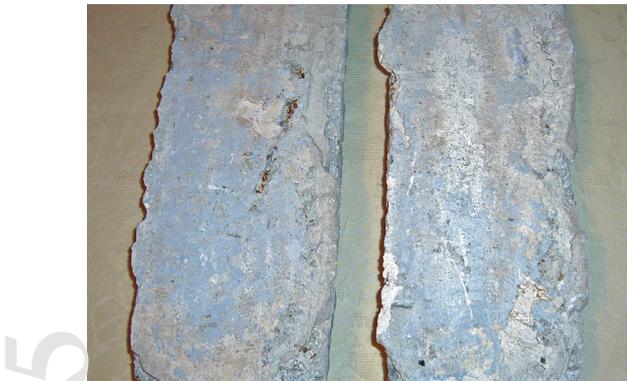
**4. INCORRECT INSTALLATION ON A WET SKIM COAT.**

Installation on plasterboard with a continuous glue skim coat newly applied caused the stone and adhesive to come off completely. When a fixing coat is applied to the base it is not possible to apply adhesive until it is set completely.

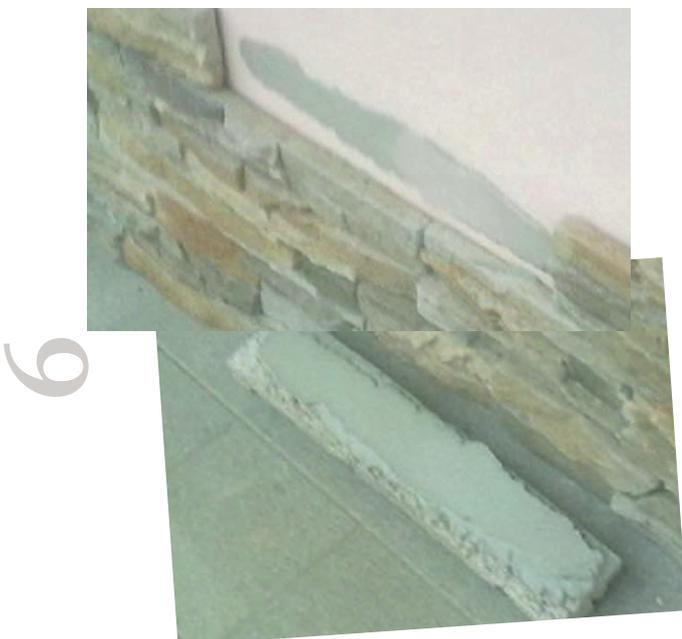
**5. DETACHMENT WITH SURFACE PRIMERS.**

The back sections of the P16 Scaglia model shown in the photograph had bonded perfectly, with adhesive spread well with a double application. The only issue is the blue mark which is due to the surface primer. It is crucial to distinguish between surface primers and deep primers. The former offer no support and the latter function with an absorbent base. If in doubt avoid using them and adopt another solution.

(See section 6 - Preparation of the Base).

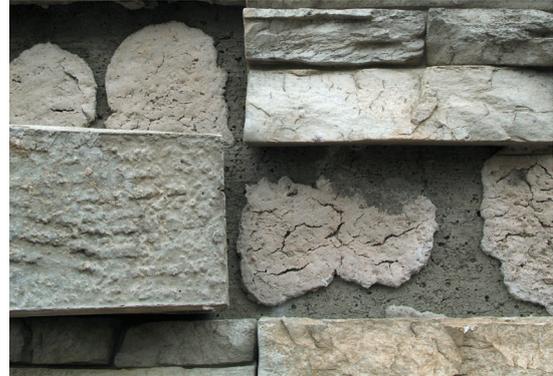
**7. INCORRECT INSTALLATION WITH 'DOTTED' ADHESIVE**

resulting in the possibility of longer sections breaking near gaps. A double application has not been put on the piece and the base, in accordance with the wet-on-wet installation technique. It can also be clearly noted that the adhesive has overheated due to installation during the summer on a base which was too hot and absorbent.

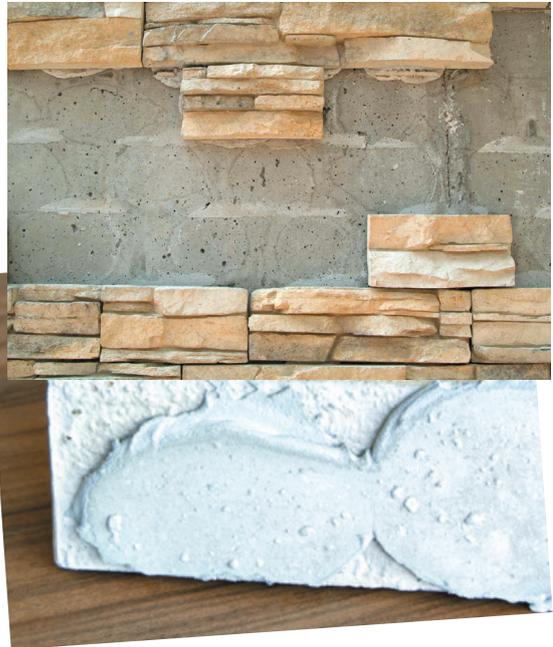
**8. INCORRECT INSTALLATION WITH 'DOTTED' ADHESIVE ON REINFORCED CONCRETE**

in winter with the wall temperature close to or lower than 0°C and the presence of a film of water due to washing the base with a pressure washer and applying adhesive without waiting for it to be completely dry. The same issue can transpire in the presence of release agents, waterproofing treatments or bonding additives that form a film. A double application has not been put on the piece and base, in accordance with a wet-on-wet installation technique.

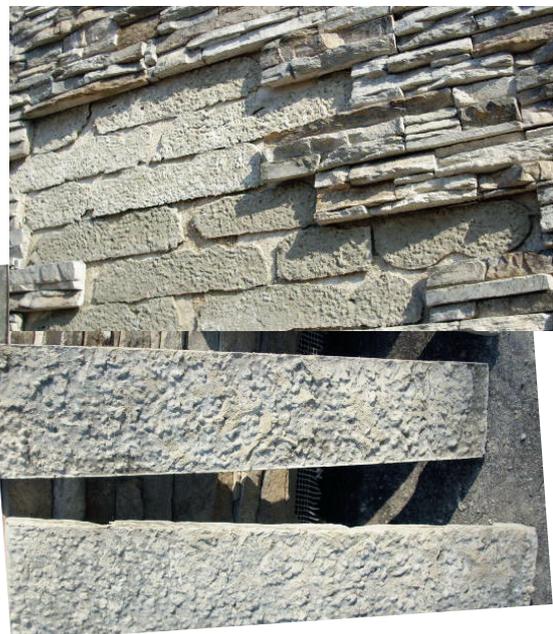
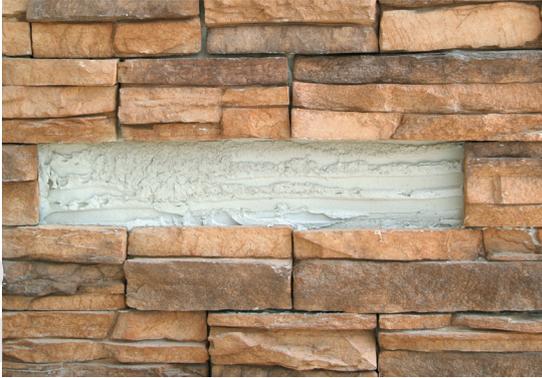
**9. INCORRECT INSTALLATION WITH TOO LOW TEMPERATURES**

and resulting frost shattering of the adhesive. It can also be noted that a double application was not carried out, even though in this case it would only have prolonged adhesion by a few years and would not have prevented detachment in any case.

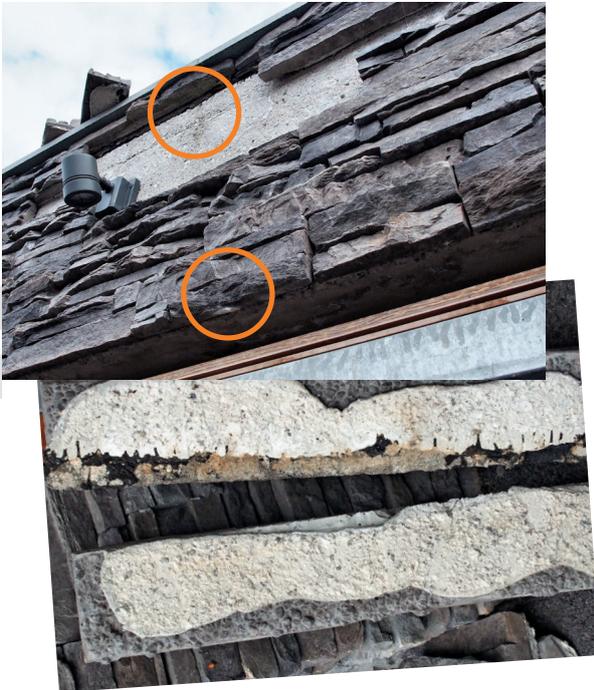
**10. INCORRECT INSTALLATION USING SPATULA WITH TEETH**

and application of **Geocoll®** on the base only, with the piece simply being fitted with a ceramic tile technique. Grip is insufficient for withstanding the forces resulting from the various thermal expansions between the wall covering and the loadbearing base. A double application has not been put on the piece and base, in accordance with a wet-on-wet installation technique.
