The guaranteed murogeopietra installation solution on EPS preserves the solidity of the façade.

The new LEPIR II test confirms that the **murogeopietra** solution on **EPS** fully complies with fire safety standards for buildings.

CSTB - LEPIR 2 - Propagation of fire outside façades for buildings subject to specific regulations (residential buildings, public buildings, tower blocks) - FRANCE August 2018

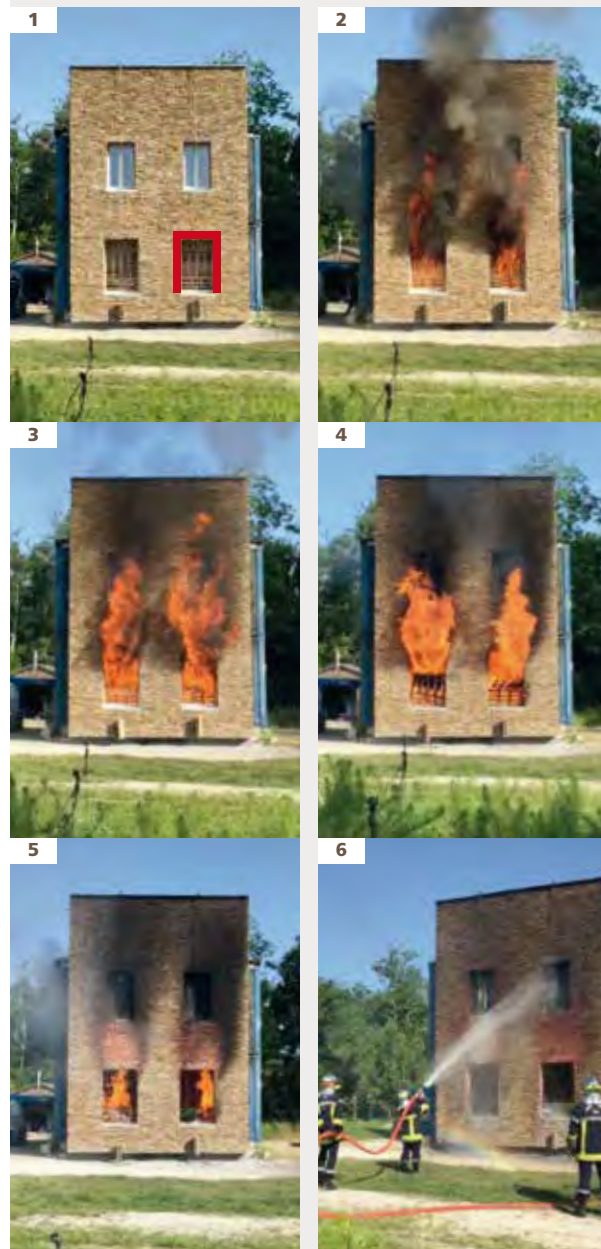
MUROGEOPIETRA ON EPS BEHAVIOR AT FIRE.

The LEPIR II test involves setting fire to a façade fitted to a structure with two floors. The source that ignites and propagates the fire is on the ground floor and the progress of the fire is controlled through openings in the rear room wall. The temperature and radiant energy are measured. The ETAG 004 procedure is used to fit 20-cm EPS panels providing external insulation to the wall, which is made of perforated cement blocks 20 cm thick. The Geopietra manufactured stone veneer is then installed using the guaranteed procedure. The window sills are made with Geocover flashing. A panel of rock wool 20 cm thick was inserted at the architrave and jambs of the right window, which was deliberately omitted from the left window to further stress the façade cladding. Two 3-cwt piles of wood were placed on the ground floor in front of the windows, which were open and constituted the flow path propagating the fire. 6 internal thermocouples measured flow path temperatures, and another 14 placed 10 cm from the surface of the wall and distributed vertically over the entire height of the wall, measured the ambient temperature of the façade.

1. The fire sources are lit and the initial fumes are released. Right side has rock wool reinforcement above the window.
2. After 1 minute 20 seconds the flames are already engulfing 3/4 of the windows on the upper floor.
3. After 5 minutes the temperature of the façade reaches approximately 800 °C and on the left side (with no rock wool protection) the glazing on the upper floor starts breaking.
4. After 8 minutes the façade reaches the maximum temperature of approximately 1100 °C and flames engulf the left window jambs.
5. After an hour, when all the fire source fuel has been used, it can be observed that the façade has not collapsed or yielded.
6. The fire fighters use strong jets of water to put out the fire, creating considerable thermal shock on the wall, but even when persisting on areas most stressed by the test, no collapse is observed.

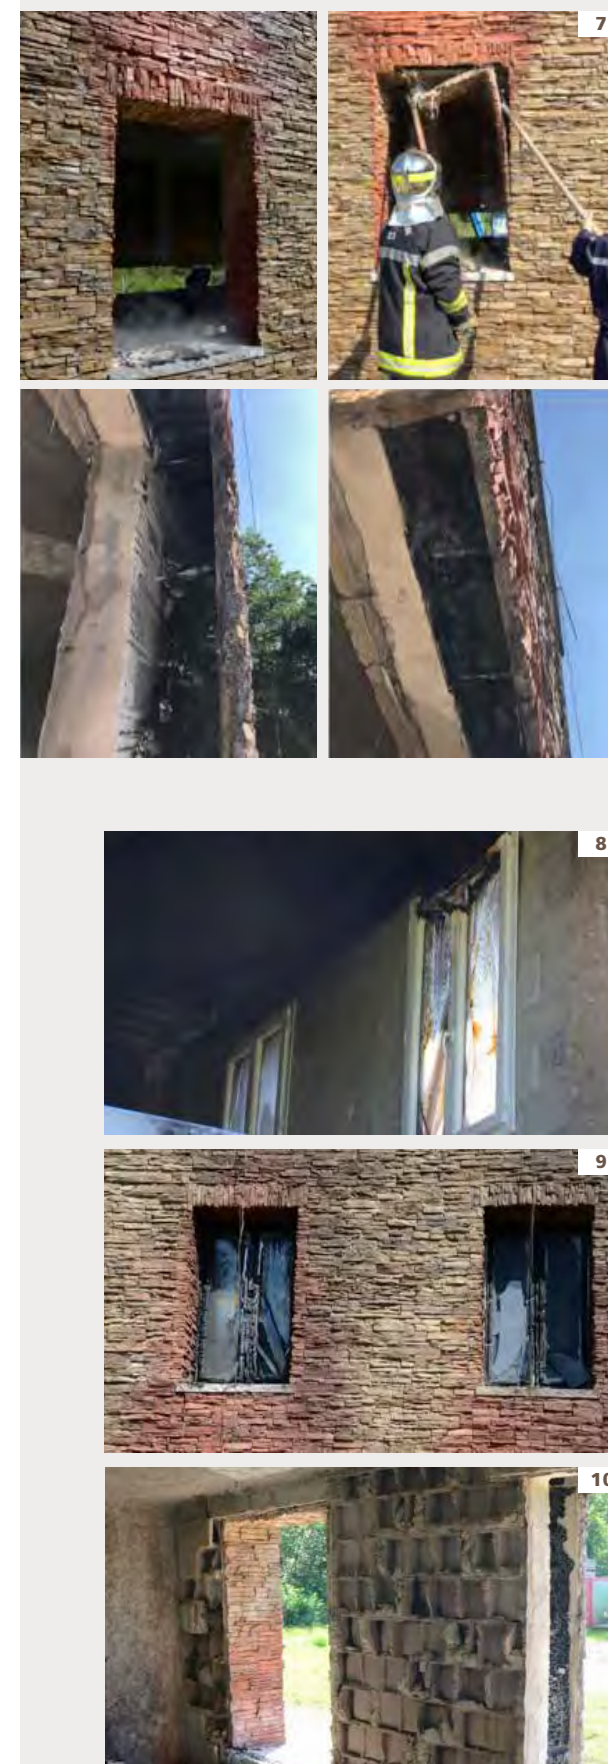
Visual inspection after completing the test.

7. The stone cladding was difficult to remove from the left window jamb and architrave. At the crack created through the thermal shock, it can be noted that in the absence of the panel of rock wool, the underlying EPS insulation has sublimed, whereas the guaranteed solution (Technical Manual section 6.21) has contributed to keeping the layers of adhesive, mesh and stone perfectly anchored to the base via the wall plugs.

8. The barrier effect of the rock wool panel was significant in triggering a protective reaction against the flames on the wall, reducing the temperature and preventing the flames from engulfing the frames on the upper floor.

9. The PVC frame on the left window was unable to withstand the fire, allowing the flames to spread inside. Although the right window frame was ruined it withstood the fire, remaining hermetically sealed against the flames and the fumes.

10. It can be observed inside that the cellular cement bricks in the room where the fire propagated literally exploded due to the excessive heat.

murogeopietra on EPS meets criteria for non-propagation of a flame front beyond the next floor level, and is authorised to cover R+2 category public buildings.
